3M ESPE

Making Better Impressions

Trouble

Shooting
Guide

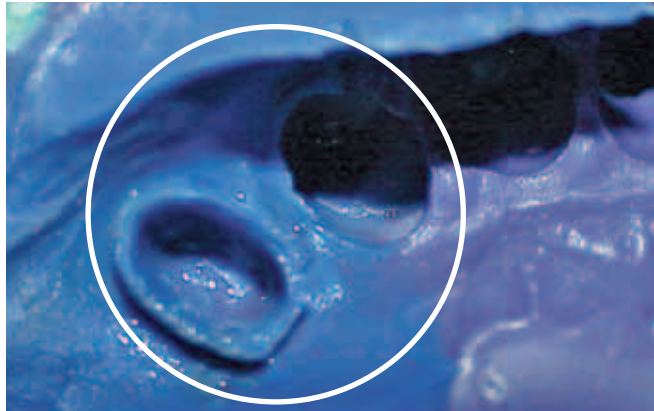
Visual Appearance: Impression not completely set. Shiny, no detail of site.

Result: Inadequate surface detail on stone cast, poor fitting restorations.

Sulfur inhibition due to contact of latex gloves with tissue/tooth/retraction material or impression material.

Residues from custom temporary or provisional cements (acrylics) present.

Inhibited Setting

Wear gloves proven not to contain traces of sulfur.

If contamination is suspected, scrub affected area with diluted hydrogen peroxide.

Do not use impressions already used to fabricate the temporary restoration.

Fabricate the temporary crown or bridge after final impression has been made.

Remove air-inhibited layer on the exposed surface with an alcohol wipe before making final impression.

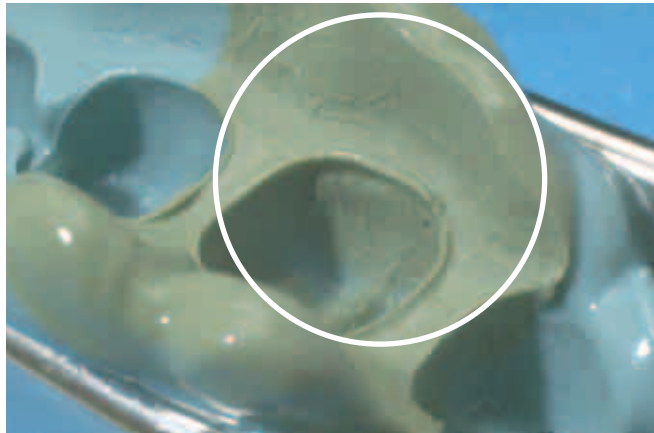
Surface Inhibition

Substances with pH < 4 inhibit setting reaction, most commonly by the contact with acidic retraction materials and hemostatic agents containing epinephrine or ferric sulfates.

Expired impression material does not set properly, elastomeric properties are insufficient.

Use retraction materials having pH ≥ 4 .

Select retraction materials and hemostatic agents not containing these chemicals.

Rinse, remove, dilute hemostatic solution with water spray and suction. Dry before taking the impression.

Check expiration date of impression material.

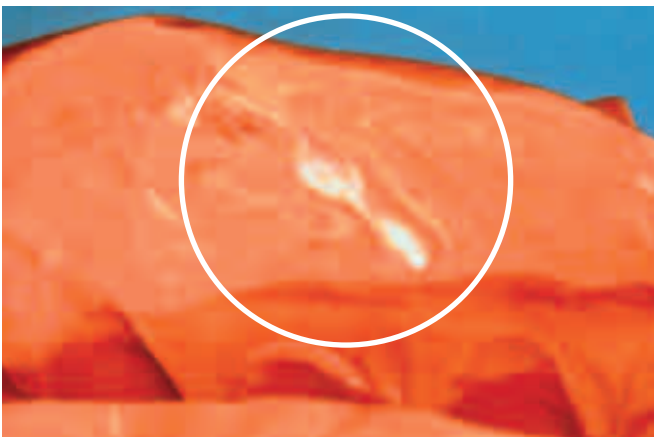
Inadequate mix.

Inadequate Mix

Bleed before applying mix tip to ensure even dispensing.

Use mix tip according to manufacturer's instruction for use.

Ensure mix tip is correctly attached.

When using hand-mix materials ensure correct mixing ratio and thorough mix of catalyst and base paste.

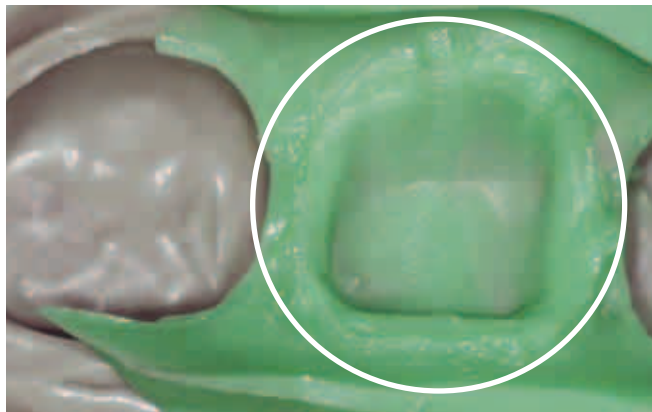
Visual Appearance: Muted detail reproduction.

Result: Crowns may be too tight, or loose, and not fit correctly.

CAUSE	SOLUTION
Impression material stored at elevated temperature.	Store impression material at room temperature.
Impression material stored at too low a temperature (prolongs the setting reactions, changes viscosity and requires exceptionally high extrusion forces for automix materials).	Keep impression material at a temperature of 18°C/64°F at least one day prior use.
Thick blood/saliva pooled around prep.	Remove blood and saliva prior to making impression. Use 2-step impression technique.
Inadequate retraction of sulcus around prep.	Use good retraction technique, with proper moisture control.
Exceeding the working time.	Follow manufacturer's working time specifications. Choose material with longer working time.
Inadequate disinfection effects surface quality (detail reproduction) and dimensional stability.	Use water based disinfectants according to FDA guidelines. Follow manufacturer's instructions for use.

Lack of Impression Detail

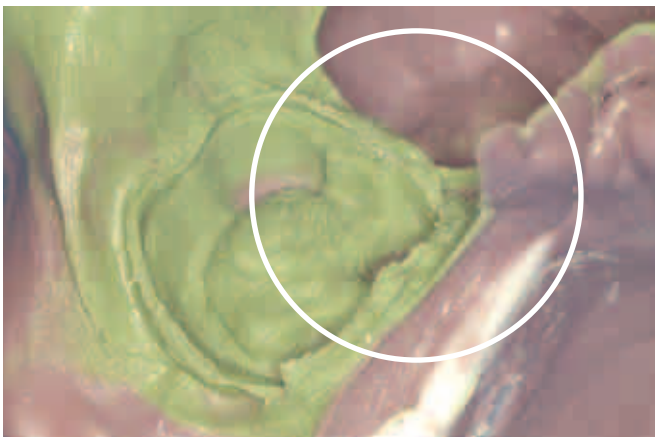
Substances with $\text{pH} < 4$ inhibit setting reaction, most commonly by contact with acidic retraction materials and hemostatic agents containing epinephrine or ferric sulfates.

Poor Retraction and Syringing Technique

Use retraction materials having $\text{pH} \geq 4$.

Select retraction materials and hemostatic agents not containing these chemicals.

Rinse, remove, and dilute hemostatic solution from the preparation with water spray and suction. Dry before taking the impression.

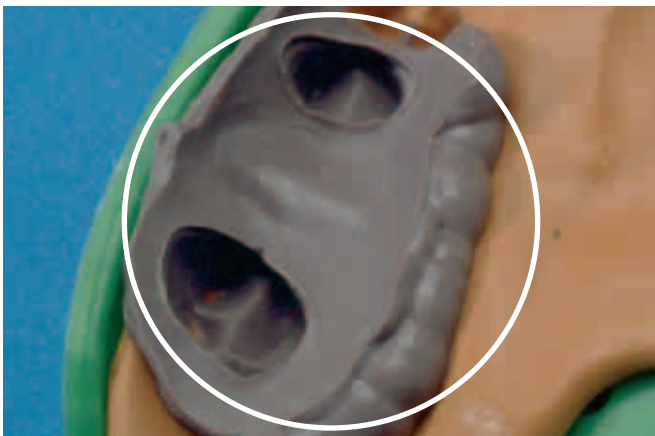
Exceeding the Working Time

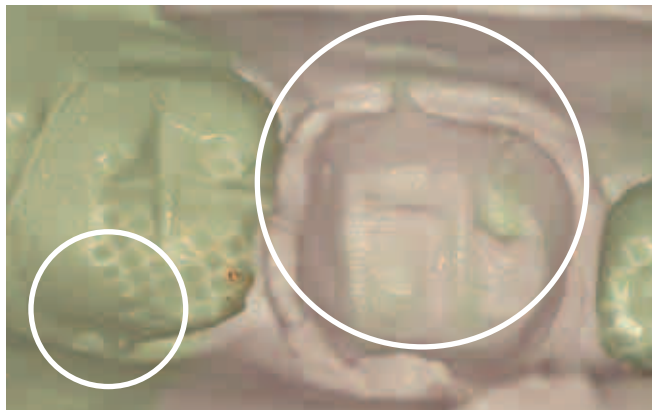
Visual Appearance: Voids/holes on margin of the prepared teeth. Incomplete margin.

Result: The fit and function of the final restoration may be compromised. Short crown margins and/or open margins.

CAUSE	SOLUTION
Air trapped in intraoral syringe.	Properly bleed filled elastomer syringe. Keep tip immersed in material when loading syringe. Do not stop when in the middle of loading syringe.
Air trapped while filling impression tray.	Keep mix tip immersed in tray material while filling the tray.
Improper syringe technique.	Keep syringe tip immersed in wash material to avoid entrapping air. Wiggle and stir while syringing. Push material forward.
Inadequate coverage of marginal area with light body impression material.	Use wash material liberally on preparation and abutments.

Void Caused by Syringe Technique

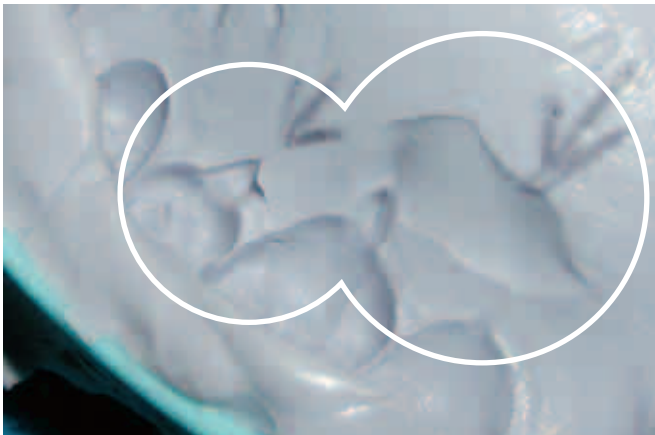
Blood and saliva contamination around prep.

Trapped Air or Moisture

Use good moisture control technique. Rinse and dry prep area before taking the impression.

Stop bleeding by using appropriate retraction technique and hemostatic agent. Leave cord in sulcus until no blood or saliva are present before syringing the light body impression material. Consider two-cord retraction to displace tissue and control fluids.

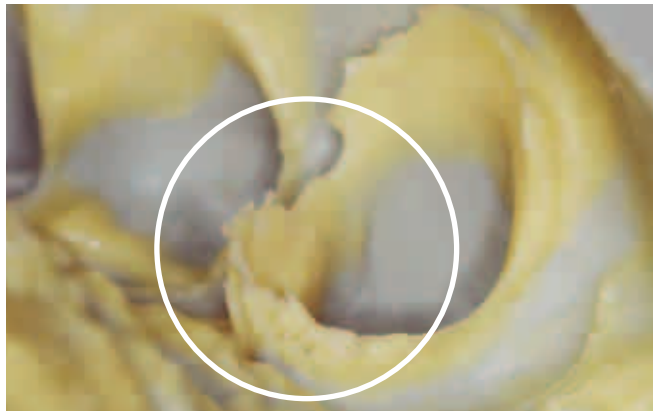
Visual Appearance: Rip, or visible tearing on the margin of the preparation.

Result: Short crown margins and/or open margins.

CAUSE	SOLUTION
Expired impression material.	Check expiration date of impression material.
Inadequate mix.	Bleed before applying mix tip to ensure even dispensing. Use proper mix tip. Ensure mixing instructions are followed and materials have a streak-free appearance.
Insufficient retraction.	Displace tissue to allow the impression material to access prepared area. Consider two-cord retraction. Leave pilot cord in the sulcus when taking the impression. Use impression material with sufficient tear resistance.

Poor Retraction — Insufficient Tear Resistance

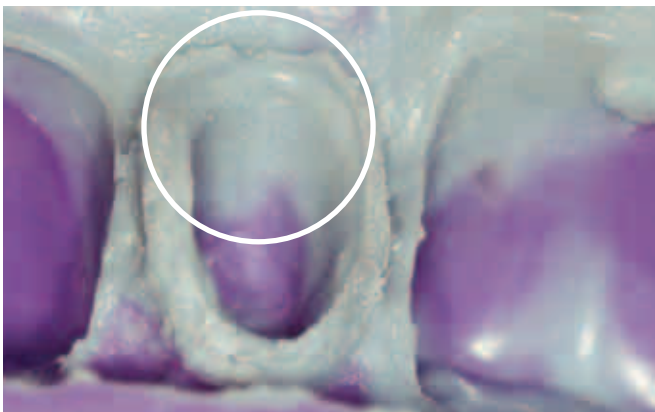
Substances with $\text{pH} < 4$ inhibit setting reaction, most commonly by contact with acidic retraction materials and hemostatic agents containing epinephrine or ferric sulfates.

Tearing at the Margin

Use retraction materials with a $\text{pH} \geq 4$.

Select retraction materials and hemostatic agents that do not contain these chemicals.

Rinse, remove, and dilute hemostatic solution from the preparation with water spray and suction. Dry before taking the impression.

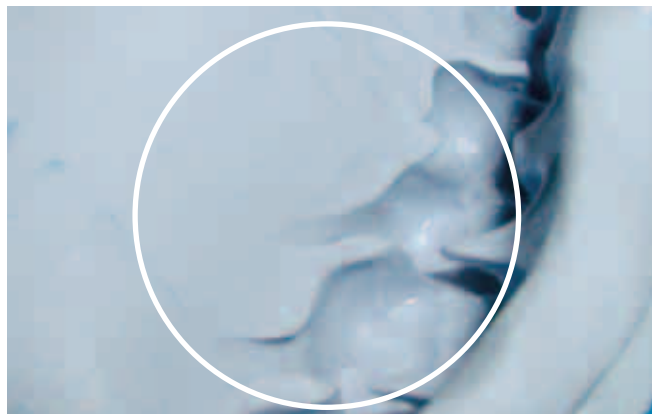
Visual Appearance: V-shaped void, trough-like.

Result: Failure to capture complete and accurate dentition.

CAUSE	SOLUTION
Exceeding the working time.	Follow manufacturer's working time specifications. Choose material with longer working time.
Tray movement or repositioning after seating.	Do not move tray after seating.
Insufficient amount of impression material used.	Use more material to create back flow effect.
Impression tray does not support flow of impression material.	Use lingual stops. Use an impression tray that supports the flow of the material.

Lingual Pulls

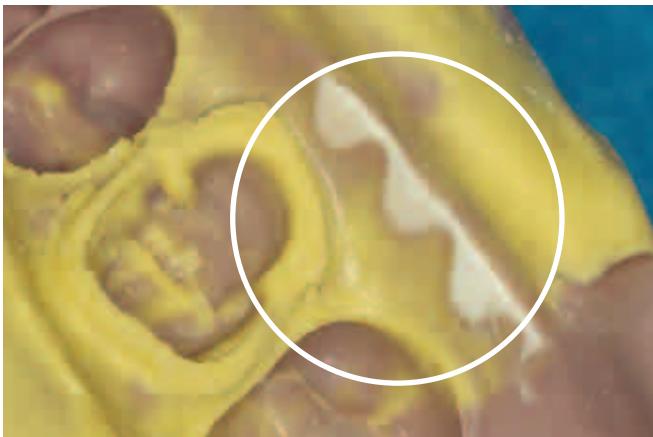
Visual Appearance: Show-through of tray. Impression tray exposed.

Result: Restoration may have slight distortion at marginal area, or rocks.

CAUSE	SOLUTION
Prepared teeth contact the sides or bottom of impression tray.	Use proper size tray. Test various tray sizes to ensure proper size.
Tooth contact with the pre-set tray material when using the two-step technique.	Carve out tray material properly before applying wash.
Insufficient impression material used.	Fill tray adequately.

Contact with Impression Tray

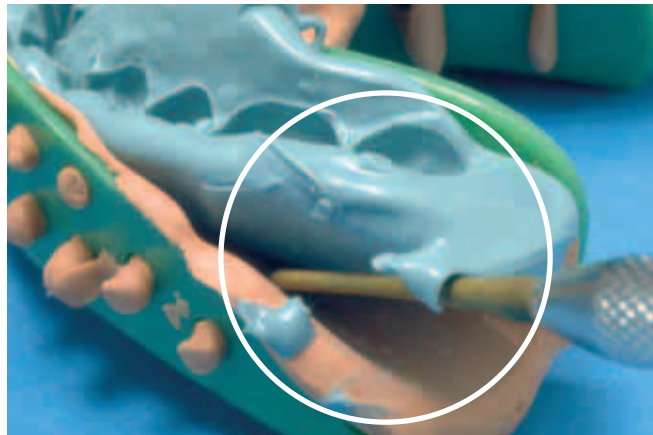
Visual Appearance: Heavy body and light body materials not blended, or mixed together.

Result: Restoration will not seat or fit properly.

Exceeding the working time.

Impression material stored at elevated temperature.

Sulfur or acrylic contamination of pre-set heavy body material in two-step technique.

Poor Bond Between Heavy Body and Light Body Material

Follow manufacturer's working time specifications.

Choose material with longer working time.

Store impression material at room temperature.

Avoid contact with sulfur contaminants:
Wear gloves proven not to contain traces of sulfur.

Avoid contact with acrylic and methacrylic contaminants: Ensure impression material does not come into contact with methacrylate residue from acrylate temporary materials.

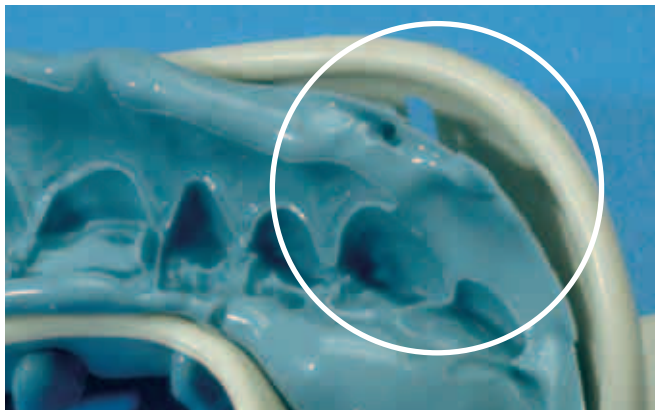
Visual Appearance: Impression pulling away from the sides/bottom of tray.

Result: Crown(s) may be tight and not seat fully, or require excessive internal adjustment.

CAUSE	SOLUTION
No tray adhesive used.	Use tray adhesive.
Incompatible tray adhesive used.	Use appropriate tray adhesive. VPS adhesive for VPS. Polyether adhesive for polyether materials.
Inadequate drying time for tray adhesive.	Follow manufacturer's instructions for application, and drying time.
Thin plastic trays allow deflection, which can cause rebound upon removal.	Use a tray that fits better, and is stiffer and more rigid.

Separation of Material from Tray

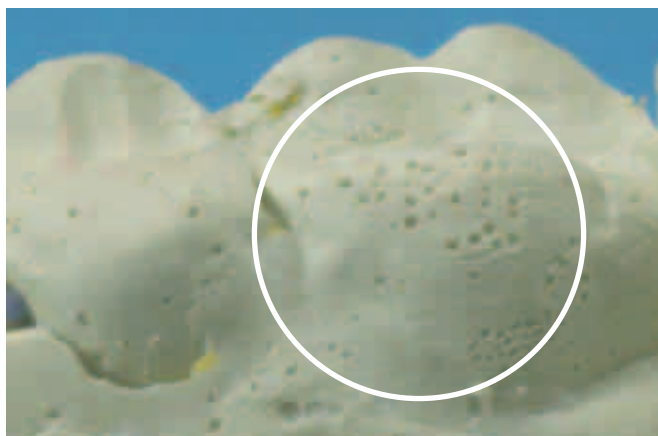
Hydrogen gas emission.

Stone Model with Hydrogen Evolution Voids

Follow manufacturer’s instruction for casting time.

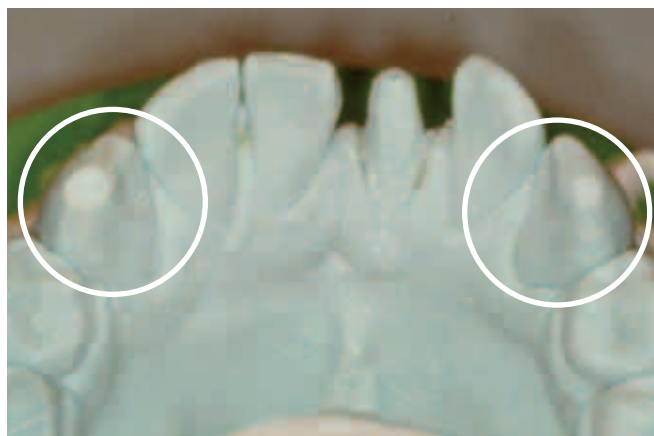
Visual Appearance: Voids on margin, powdery cusp tips on incisal edges on prepared tooth. “Golf-ball” appearance of stone model.

Tooth contact with impression tray, or gauze of double bite tray causes water to leach out of the tray, dehydrating the stone.

Stone Model with Powdery Cusp Tips

Instruct patient to bite passively in centric occlusion when using dual arch trays.

Fill tray with sufficient amount of material.
